# Parts4Marx Tech Tips

010

## Marx Glendale Talking Station Record Player

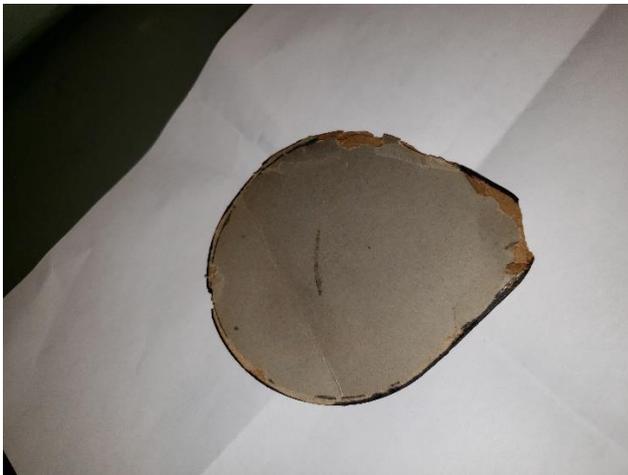
Often the thick paper cover is loose or missing. This is a key element in how the record player works, as it both provides tension to keep the record player needle in the record groove and provides sound amplification.

Further examination of the interior of the record player reveals the needle attached to the tone arm, which pivots on an eyelet attached to the extension in the plastic base. An additional arm is attached above the needle and contains a small, round, raised surface that comes in contact with the thick paper cover that provides the tension that keeps the needle in the record groove. It also transmits the sound vibrations from the record groove to the needle to the thick paper cover that acts like a speaker. The sound is greatly amplified when everything is connected. Low volume can result if the connections are interrupted.

Attached to the axle formed by the crank is a pivoting arm with a light wire spring. The spring fits in a small groove in the pivoting arm and rests upon the axle as shown. When the needle moves to the inside grooves after playing the sounds it contacts the small tab at the bend which pulls the pivoting arm away from the axle and increases the tension on the spring. Once the tension is sufficient, the pivoting arm snaps from the needle, propelling the tone arm back to the starting groove of the record, to cycle through the sound once again. If the sound is not cycling continually, either the spring is broken, misplaced or missing, or the needle is not moving to the most inner grooves.
